FlashSeal

***The Solution for Deteriorated
Flashings Around Chimneys,
Stacks, and Vents***

ELASTOMERIC FLASHING SEALANT

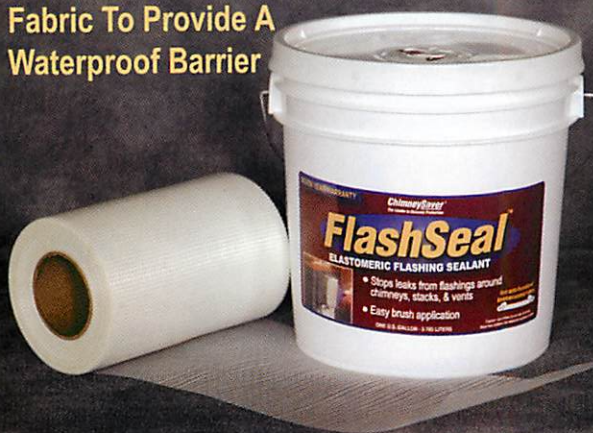
FlashSeal Elastomeric Sealant is available in one gallon containers and is used in conjunction with FlashSeal Reinforcement Fabric sold separately in 150 ft. rolls. One roll of Reinforcement Fabric will last through 3 - 4 gallons of FlashSeal.

**Use with Reinforcement
Fabric To Provide A
Waterproof Barrier**

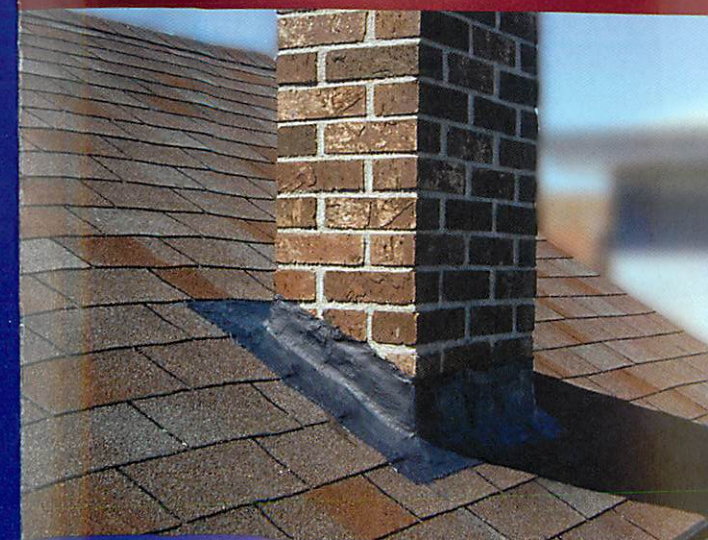
Deteriorated Flashings

Flashing is the material at the base of chimneys, stacks and vents that is designed to waterproof the juncture where they penetrate the roof. Faulty or deteriorated flashings can cause leaks and water damage to the surrounding roof deck or eventually the interior finishes of your home.

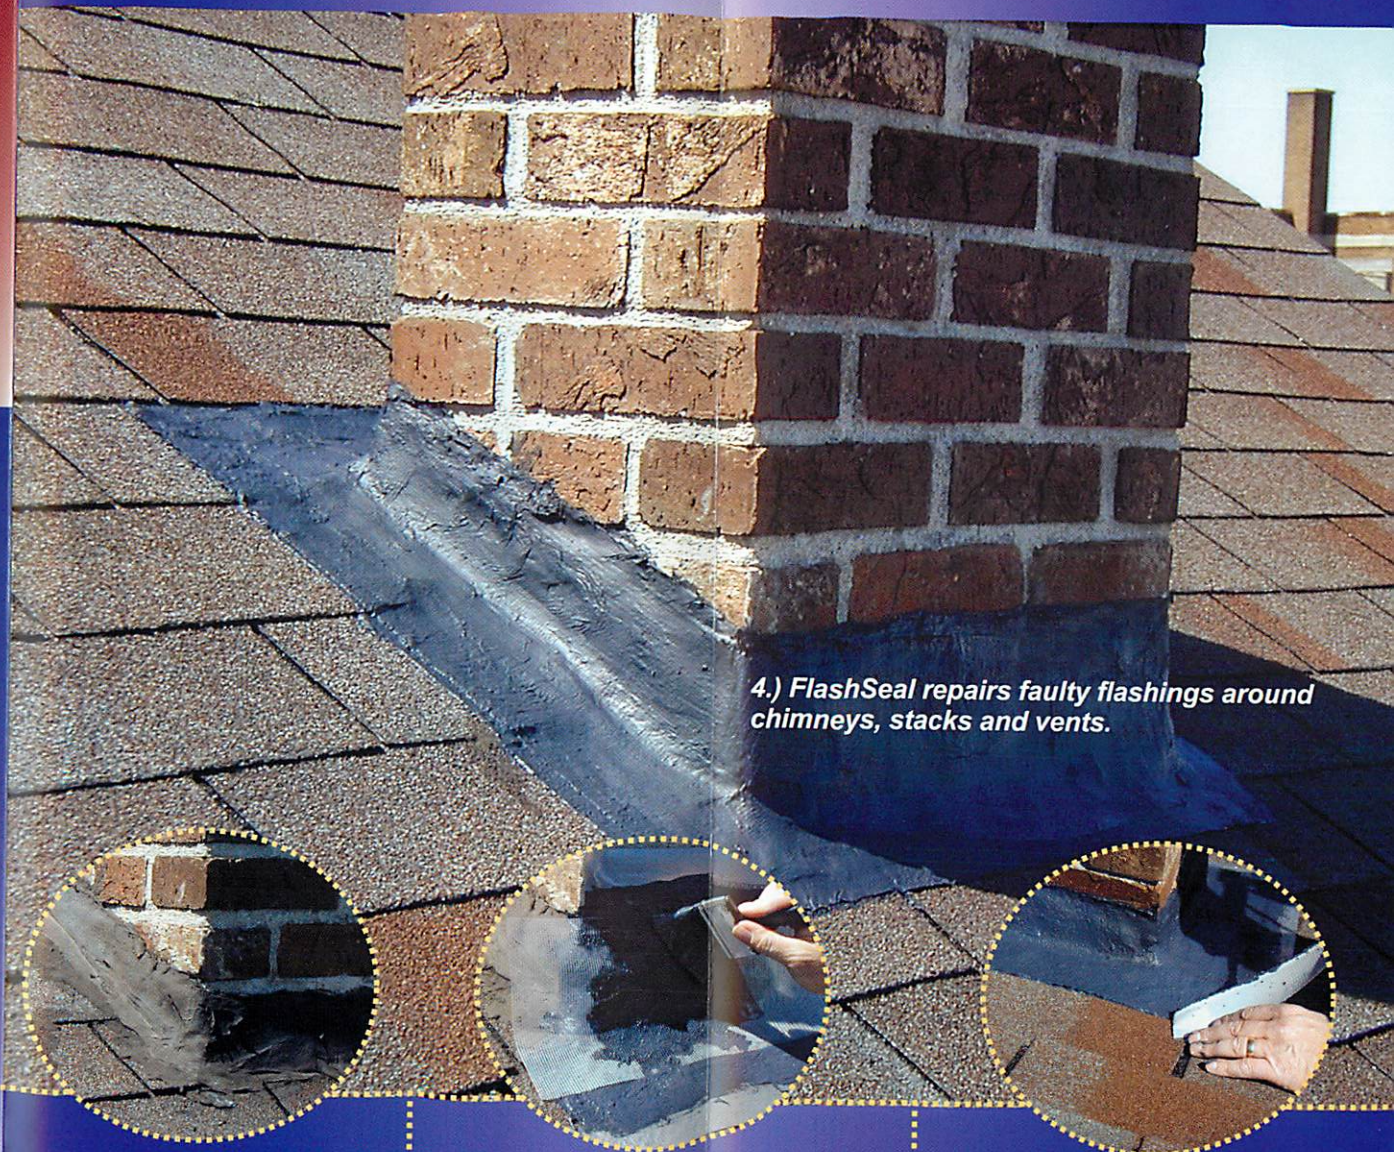
4.) FlashSeal repairs faulty flashings around chimneys, stacks and vents.

1.) Chimney with cracked and deteriorated flashing.

2.) For added strength and flexibility a fiberglass fabric is embedded between 2 coats of FlashSeal Elastomeric Sealant

3.) In most cases the roof deck and chimney are taped off to produce a neat appearance of the finished application.

A properly installed FlashSeal application is like installing a custom fit waterproof boot around the base of your chimney. FlashSeal's strength and flexibility will provide years of trouble free service to help stop the damaging effects of water that can enter your home from a faulty or deteriorated flashing system.

A professionally installed FlashSeal application is like installing a custom fit waterproof boot at the base of your chimney.
