PCR

Poultice Creosote Remover

Centuries-Old Problem NOW Easily Solved with this Modern Solution

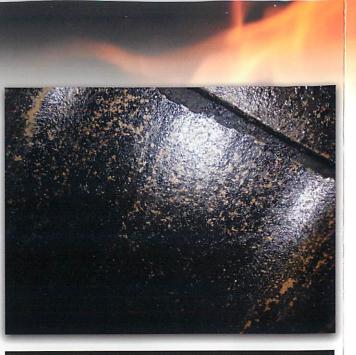
Actual flue tile with 3rd degree glazed creosote, removed from the chimney and cut in half to demonstrate the effectiveness of PCR.
